Corrosion hazards and inhibitor protection in the seawater injection system on the Baltic sea rig

K. Domanska, 1* P. Iglinski, 2 J. Orlikowski, 3 K. Zakowski 3 and K. Darowicki 3

¹Exploitation & Reservoir Engineering Department, LOTOS Petrobaltic Ltd, 9 Stary Dwor Street, 80-758 Gdansk, Poland

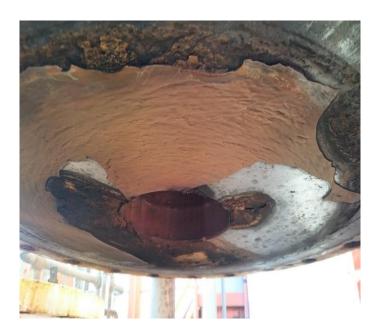
The operational experience of the Baltic Beta rig has shown a significant degree of corrosion aggressiveness of water, which necessitates frequent repairs of the installation, especially downstream of the dual media filters. Such a poor condition of the installation had a negative impact on the injected water quality. The average content of total suspended solids content in the last year was 2.25 mg/l and total iron content was 1.19 mg/l. These values exceed the permissible quality indices for injected water. Figure 2 presents the actual state of the hatches of the dual media filters.

Figure 2. Surface of the inner parts of the dual media filter.

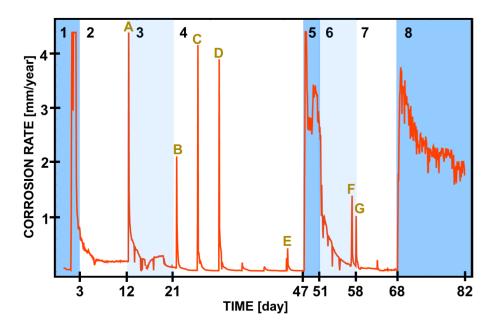
The average rate of corrosion affecting the S236JR non-alloy steel remained at the level of 1 mm/year, which is ten times higher than the safe level of 0.1 mm/year.

Figure 3. Corrosion rate measured at a point downstream of the deaerator tower (sensor 2).

In the periods 1, 5 and 8 (dark blue area), when the internal circuit was in use, the water flow through the installation amounted to 80 m³/h, no deoxidization was performed, and the water chlorination process was carried out only to the point at which the free chlorine content reached the level of 0.2 ppm. Corrosion inhibitor was switched off. The average corrosion rates noted in these periods of time were, respectively, 1.68, 2.66 and 2.38 mm/year. Such high levels were associated with high water expenditures (erosion, corrosion), the presence of oxygen at the level of 12.5 ppm, free chlorine at the level of 0.2 ppm, and chlorides. In each of these periods the corrosion rate was decreasing gradually, indicating that some corrosion products might have developed on the metal surface.

In the periods 3 and 6 (light blue area), the process of water injections into the oil formation was being performed. The installation operated at the flow rate of $40 \text{ m}^3/\text{h}$, while water was being deoxygenated and corrosion inhibitor was added. The average levels of corrosion rate recorded in these periods were, respectively, 0.26 and 0.36 mm/year. The low oxygen content, lack of free chlorine, lower water flow rate and dosage of corrosion inhibitor brought the corrosion rate down significantly. Despite this fact, its level was still too high. This might prove the occurrence of MIC or low efficiency of the corrosion inhibitor. These periods were characterized also by a gradual decrease in the corrosion rate. However, the corrosion rate drops occurred faster here than in the periods when the internal water circuit was switched on. This is due to the lower water flow rate, which does not wash the corrosion products off from the inner surface of the pipes and an addition of a corrosion inhibitor. Peak A in the area 3 shows when the water flow in the system was switched on and the corrosion products became detached. Peaks F and G in the area 6 result from temporary adjustments of the water flow rate.

Very interesting results were recorded in the periods marked 2, 4 and 7 (in white), when the water flow through the installation was entirely shut off, In the first period (2), the installation was filled with water without a corrosion inhibitor. The average corrosion rate was 0.33 mm/year at the time. In the periods 4 and 7 the water flow was turned on every five days for a period of one hour in order to flush the equipment with water containing the corrosion inhibitor. The average corrosion rate in this period equaled 0.129 and 0.075 mm/year, which shows that the inhibitor used is highly effective under stationary conditions, when there is no water flow through the installation. Peaks *B*, *C*, *D* and *E* occurred when large flows of water treated with corrosion inhibitor were turned on, whole the smaller peaks correspond to turning the installation on with less expenditure.

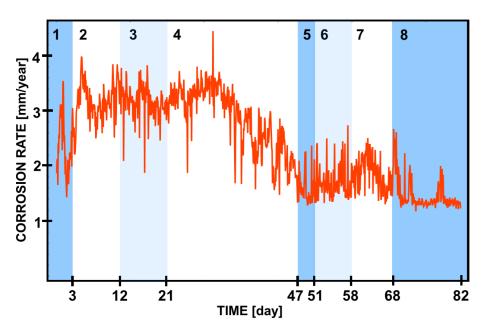
Figure 4. The corrosion rate measured at a point downstream of the dual media filters (sensor 1).

The average corrosion rate in non-alloy steel measured at a point before introduction of an inhibitor totaled 2 mm/year (which is twenty times higher than the safe level). The measured corrosion rates tended to oscillate. It was related to the fact that the installation was functioning on a periodic basis at the time. The noticeable oscillations match the devices operation schedule.

In the periods marked 1,5 and 8 (dark blue area), when the internal circuit was on, the average corrosion rates dropped down (~2.28, 1.52, 1.4 mm/year). When the water was being injected (light blue area, marked 3 and 6) and flow rate was 40 m³/h, the corrosion rate was higher (3.07, 1.65 mm/year). Hence, it can be noted that at this point the changes in the installation's operating mode did not have a significant impact on the corrosion rate measurements. The drop in the water flow velocity was not mirrored by a drop in the

corrosion rate. It must be also noted that at times when water was not flowing through the installation, no significant drop in the corrosion rate could be recorded. At the time when the installation remained filled with water not treated with the corrosion inhibitor (white area marked 2), the corrosion rate was 3.05 mm/year, and in the periods marked 4 and 7, when the filters were poured with water containing the corrosion inhibitor, the sensor recorded the corrosion rate of 2.74 and 1.78 mm/year. This may be a proof that chlorination of water in this part of the installation does not prevent biofilm development, and that MIC is the dominant corrosion mechanism here, which is why the corrosion inhibitor does not work properly.

We can also notice a decrease in the corrosion rate starting in the middle of period 4. Presumably, turning on a heavy water flow several times in period made some of the biofilm detach, thus slowing the microbiological corrosion rate.

A comparison of the measured corrosion rates with the contents of SRB and GHB showed only a partial correlation between these parameters. However, it must be underlined that only bacteria swimming freely in the water were analyzed. This indicator demonstrates only the potential of water to develop a biofilm. In the future, the number of bacteria in the biofilm will have to be determined to assess the possibility of MIC occurrence, as activity of bacteria proliferating in the biofilm is the main factor behind corrosion of this type. There will have to be performed a mechanical cleaning of the installation and find a new inhibitor

preventing microbiological corrosion more successfully (which may prove difficult). It is particularly important to develop a means of biological protection for the section of the installation upstream of the deaeration tower for the times when only the internal circuit is used.

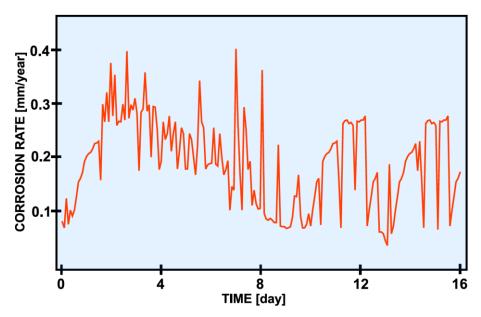
Figure 5. The corrosion rate measured downstream of the deaerator during the second inhibitor test.

The average corrosion rate during the test was 0.2 mm/year. This value is still too high, so the effectiveness of the tested inhibitor was poor. Similar to the corrosion inhibitor used previously.
