# An in-depth four-year investigation into corrosion of carbon steel materials in the secondary cooling piping of the 30 MW RSG GAS research reactor

### Abstract

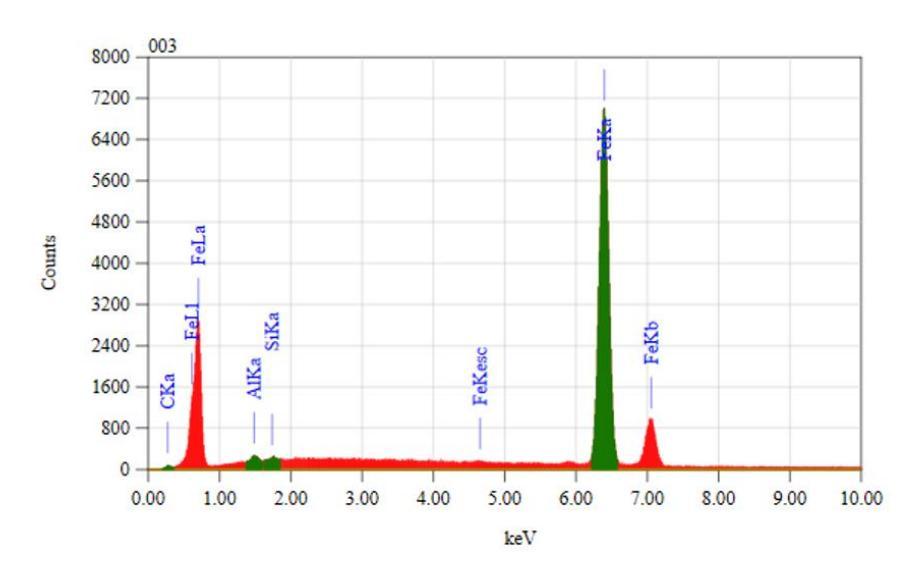
To evaluate the surface condition of CS after a 4-year immersion in PUSPIPTEK water, a scanning electron microscopy (SEM) analysis was performed using the ZAF method. The results of the SEM examination are presented in Figure 3, while the chemical elemental composition of CS, analyzed by XRF, is elaborated in Table 2.

**Figure 3.** Surface evaluation of carbon steel (CS) after 4-year immersion in PUSPIPTEK Water using SEM-ZAF analysis.

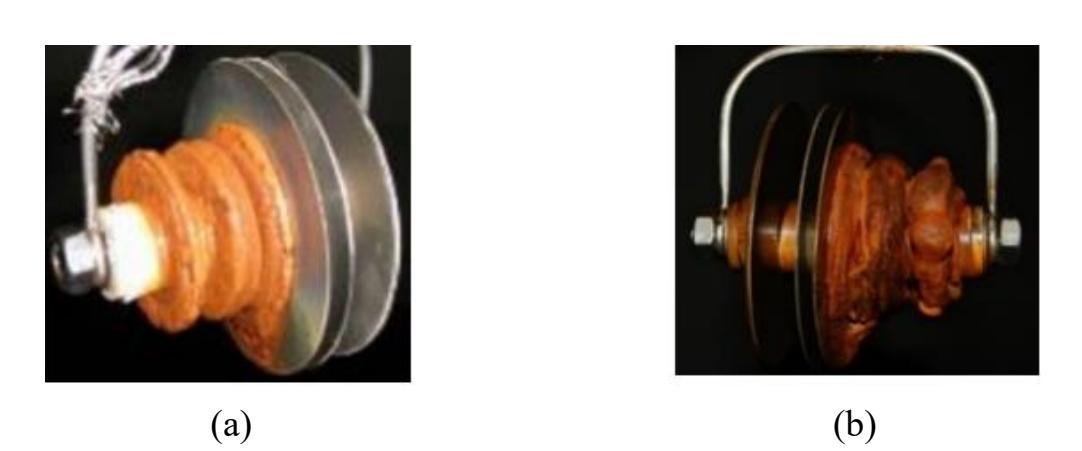
The analysis of Figure 4 reveals a notable increase in the thickness of corrosion products on carbon steel (CS) chips after a 4-year immersion period (Figure 4(b)) compared to the observations made at the 4-month mark (Figure 4(a)). This finding implies a direct correlation between prolonged immersion time and the intensified thickness of corrosion products.

The observed increase in thickness can be attributed to the continuous exposure of CS to the aqueous environment, leading to a progressive accumulation of corrosion by-products. During this prolonged exposure, various electrochemical reactions occur at the CS surface, resulting in the formation and deposition of corrosion products.

**Figure 4.** Visual examination results of coupons immersed in PUSPIPTEK water tank – vertical series. (a) 4 Months of immersion [25]; (b) 4 years of immersion.

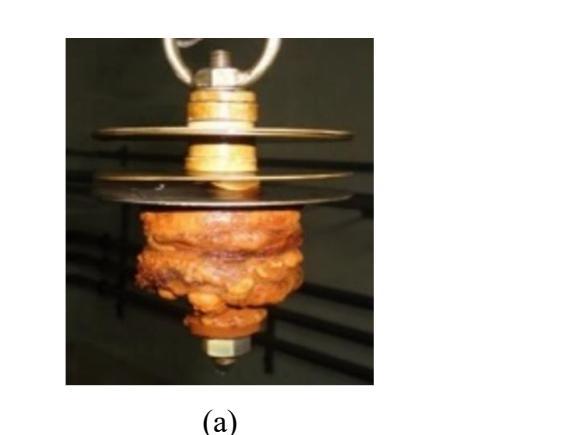
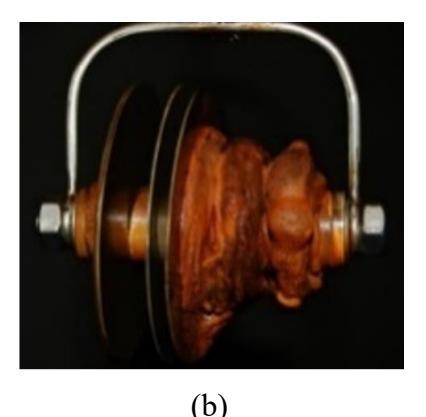
Figure 5 offers a comprehensive comparative assessment of visual observations between the horizontal and vertical series. In both configurations, corrosion products conspicuously accumulate on CS plates, uniformly covering the entire surface, exhibiting characteristics indicative of uniform, crevice, or galvanic corrosion. The compounds formed display a spectrum of colors, ranging from yellow, orange, red to nearly black, suggesting the presence of different oxidation states and compounds in the corrosion products.

**Figure 5.** Visual inspection results of coupons after 4 years of immersion in PUSPIPTEK water tank. (a) Horizontal coupon series, (b) vertical coupon series.

In contrast, the SS-304 chip exhibits no observable corrosion products; instead, it manifests the effects of splashes from the carbon steel corrosion products. This lack of corrosion on SS-304 indicates its enhanced corrosion resistance in comparison to CS, underscoring the material differences in their responses to the corrosive environment. The protective oxide layer formed on the surface of SS-304 contributes to its resistance against corrosion, highlighting the material's superior performance under prolonged exposure to the aggressive aqueous environment.

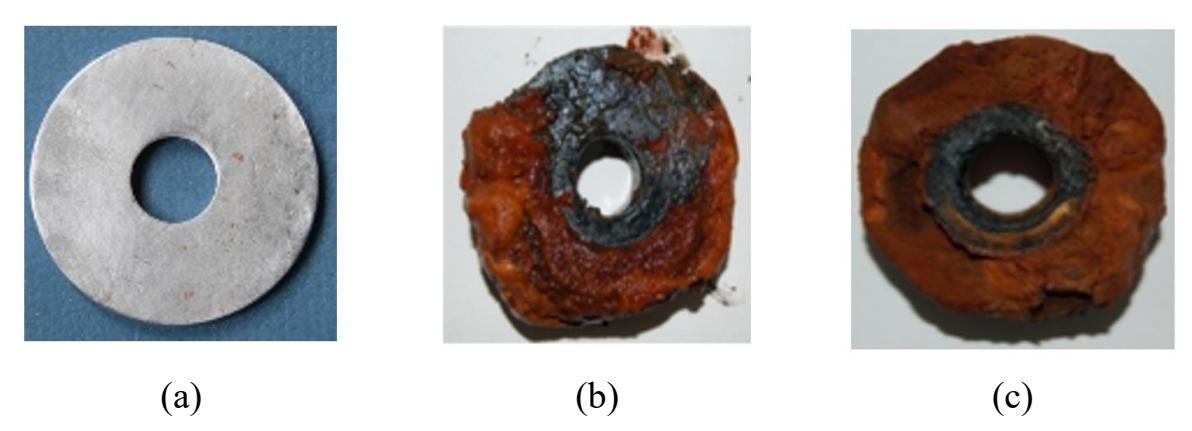
The visual alterations on the CS surface, observed from both horizontal and vertical orientations for the purpose of studying uniform corrosion, are presented in Figure 6. It is evident that the immersion position, whether horizontal or vertical, does not exhibit any significant differences after 4 years of immersion.

This lack of notable differences in visual alterations implies that the uniform corrosion experienced by the CS surface is relatively consistent regardless of its orientation during the 4-year immersion period. The consistent appearance from both horizontal and vertical perspectives suggests a uniform distribution of the corrosion process across the entire CS

surface, emphasizing the material's susceptibility to uniform corrosion under the specified immersion conditions.

**Figure 6**. Visual changes on the surface of carbon steel for uniform corrosion observation after 4 years of immersion in the PUSPIPTEK water tank. (a) Before immersion, (b) horizontal immersion, (c) vertical immersion.

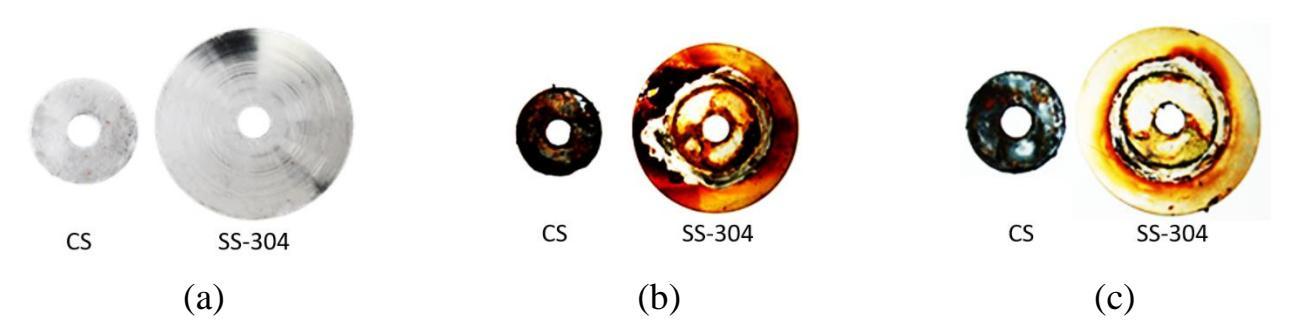
Galvanic corrosion between CS and SS-304 is shown in Figure 7. This figure effectively demonstrates the electrochemical interactions occurring between these two materials when they are in a galvanic relationship. The arrangement, as depicted both horizontally (see Figure 7b) and vertically (see Figure 7c), highlights the increased propensity of CS to undergo corrosion in contrast to the more inert behavior exhibited by SS-304. This contrast underscores the differential corrosion responses of these materials when exposed to similar conditions, providing valuable insights for material selection and corrosion prevention strategies.

In the galvanic coupling, CS serves as the anodic material, being more reactive, while SS-304 acts as the cathodic material, exhibiting less reactivity. This electrochemical pairing prompts the preferential corrosion of CS in the presence of SS-304. The observed yellow-orange color effect on the SS-304 surface is a visual indication of corrosion by-products from CS adhering to it. It is crucial to recognize that this discoloration is a surface phenomenon rather than inherent corrosion on SS-304.

A noteworthy aspect is the subsequent restoration of the SS-304 surface to its pristine state after brushing. This cleaning process emphasizes the absence of intrinsic corrosion on SS-304, as it efficiently removes the adhered CS corrosion by-products. This phenomenon accentuates the superior corrosion resistance of SS-304 under galvanic conditions and highlights its ability to resist the corrosive effects induced by the more reactive CS.

**Figure 7.** Galvanic corrosion effects on overlapping parts of carbon steel (CS) in series with SS-304 after 4 years of immersion in PUSPIPTEK water. (a) Original sample, (b) horizontal arrangement, (c) vertical arrangement. Insights into electrochemical interactions and corrosion resistance.

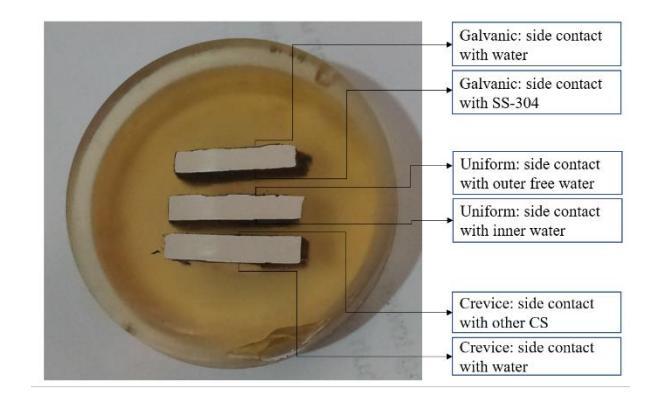
**Figure 8.** In-depth microscopic analysis of carbon steel (CS) corrosion profile, encompassing galvanic, uniform, and crevice circuits, in vertically sectioned samples embedded in epoxy.

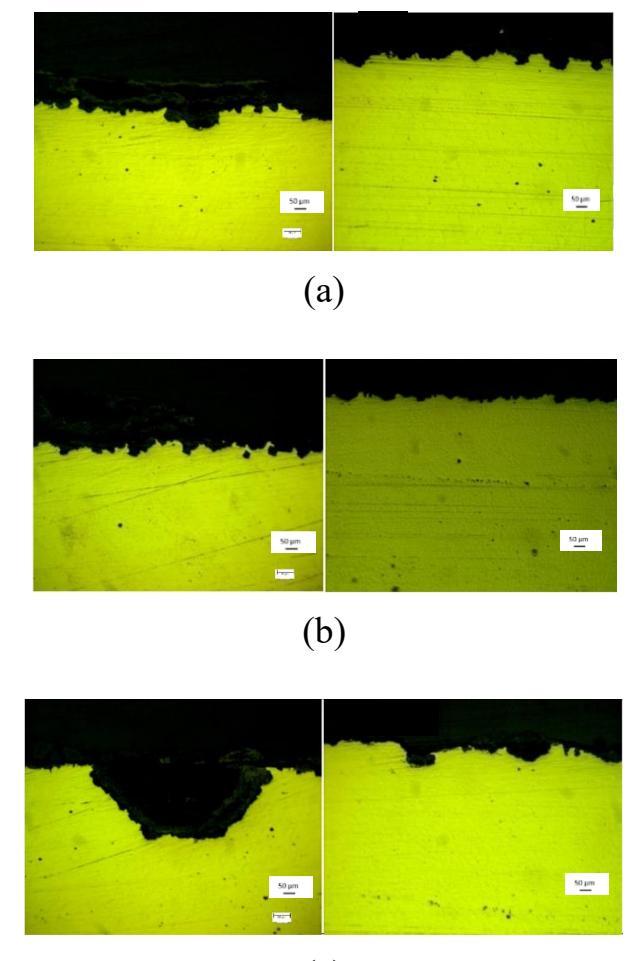
The corrosion profiles formed on carbon steel metal for the Galvanic and Crevice set coupons are clearly visible. Both Galvanic (Figure 9(a left)) and Crevice (Figure 9(b left)) configurations exhibit pitting corrosion. A distinct image of pitting corrosion with varying depths is presented in Figure 9 c. This occurrence has been extensively discussed in the existing literature, with prior studies addressing the influence of environmental factors on corrosion behavior [32, 33]. The manifestation of pitting corrosion, as observed in Figure 9 c, is a complex phenomenon influenced by multiple factors. Prior research has

established that chloride ions, present in the water, play a predominant role in inducing pitting corrosion in carbon steel [31]. The corrosive nature of chloride ions triggers localized breakdowns in the passive film on the metal surface, initiating the formation of pits. The varying depths of these pits, as evidenced in the microscopic images, further underscore the heterogeneity and severity of the corrosion process.

**Figure 9.** Macrostructural profiling of CS following 4 years of immersion in PUSPIPTEK water, a raw water source for RSG GAS secondary cooling. (a) Galvanic corrosion – left: side contact with water, right: side contact with SS-304; (b) crevice corrosion - left: side contact with other CS, right: side contact with water; (c) pitting resulting from both crevice and galvanic corrosion.

This observed pitting corrosion aligns with the well-documented susceptibility of carbon steel to chloride-induced corrosion in aqueous environments. The discussion within the literature, coupled with the visual evidence from Figure 9, strengthens the understanding of the corrosion mechanisms at play during the 4-year immersion period. The integration of theoretical insights with practical observations contributes to the broader comprehension of material degradation in similar environments, aiding in the formulation of effective corrosion mitigation strategies for practical applications.

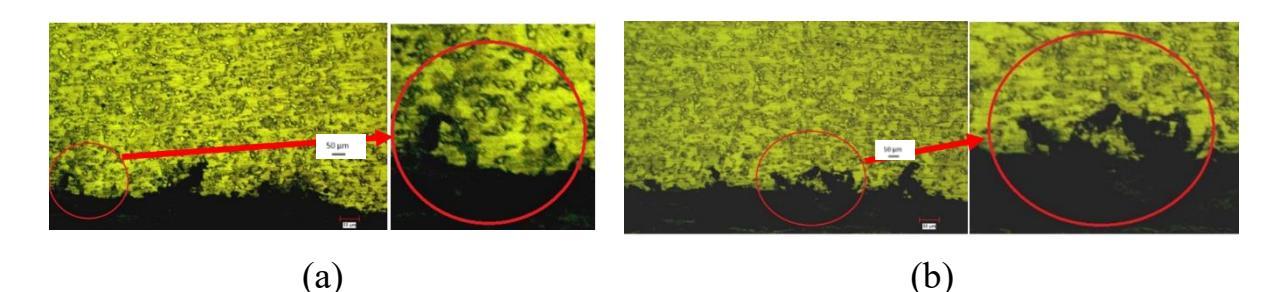
**Figure 10.** Intergranular corrosion microstructure profile of carbon steel (CS) after 4 years of immersion in PUSPIPTEK water, a raw water source for RSG GAS secondary cooling water. (a) Crevice circuit, (b) galvanic circuit.

Figure 10 provides a detailed microstructural analysis of carbon steel (CS) using microscopy at a specific magnification. The etching process employed in this observation selectively erodes the grain boundaries, enhancing their visibility. In this micrograph, ferrite is shown in a lighter color, pearlite appears more opaque, and the dark areas represent the passive layer formed by corrosion products.

The corrosion pattern observed is predominantly intergranular, characterized by corrosion predominantly occurring along the grain boundaries. This is often due to the presence of impurities at these boundaries, which are typically introduced during metal manufacturing processes such as precipitation and segregation. These impurities create a distinct layer at the grain boundaries with different physical and chemical properties compared to the bulk metal grains.

The research findings emphasize the vulnerability of CS to grain boundary corrosion, especially in aggressive environments. A notable aspect is the formation of chromium carbides (CrC) at the grain boundaries, which can lead to chromium depletion in adjacent areas. This chromium depletion makes the nearby ferritic matrix more susceptible to corrosion.

Intergranular corrosion is further exacerbated by galvanic reactions. These occur when there is electron transfer between different microstructural features acting as anodic and cathodic sites. This electron transfer leads to the formation of metal ions that react with aggressive ions like hydroxide (OH<sup>-</sup>) and chloride (Cl<sup>-</sup>) in the environment, known for their corrosive nature. Such reactions weaken the steel's grain lattice, potentially leading to the release of material into the environment, further propagating corrosion and leading to extensive pitting.

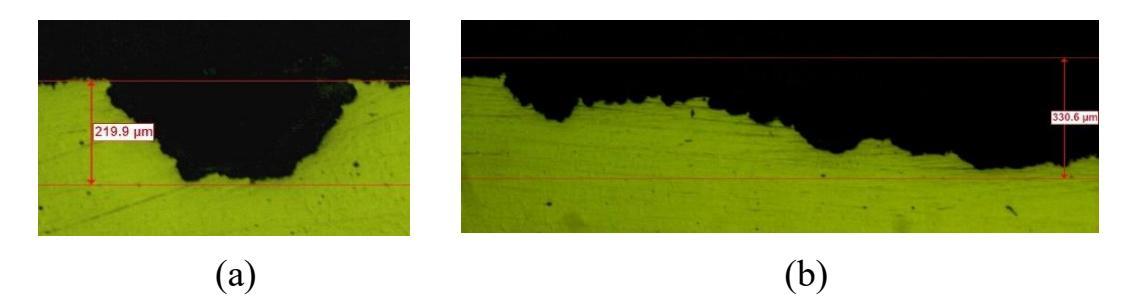
Figure 11 illustrates the severity of the corrosion, showing the maximum depth of pitting corrosion (219.9  $\mu$ m) and significant surface thinning (330.6  $\mu$ m) due to uniform

corrosion. Despite these corrosion depths being within safe limits, the study underscores the need for corrosion protection strategies, like the introduction of corrosion inhibitors to PUSPIPTEK water in the RSG GAS secondary cooling system. This measure is crucial for extending the lifespan of the material and aligns with standard practices for corrosion mitigation. It highlights a proactive approach in maintaining the structural integrity and operational safety of materials and components in corrosive environments.

**Figure 11.** Examining pitting and uniform corrosion in carbon steel (CS) coupons. (a) Pitting corrosion with a depth of 219.9  $\mu$ m, (b) uniform corrosion causing surface thinning measured at 330.6  $\mu$ m.

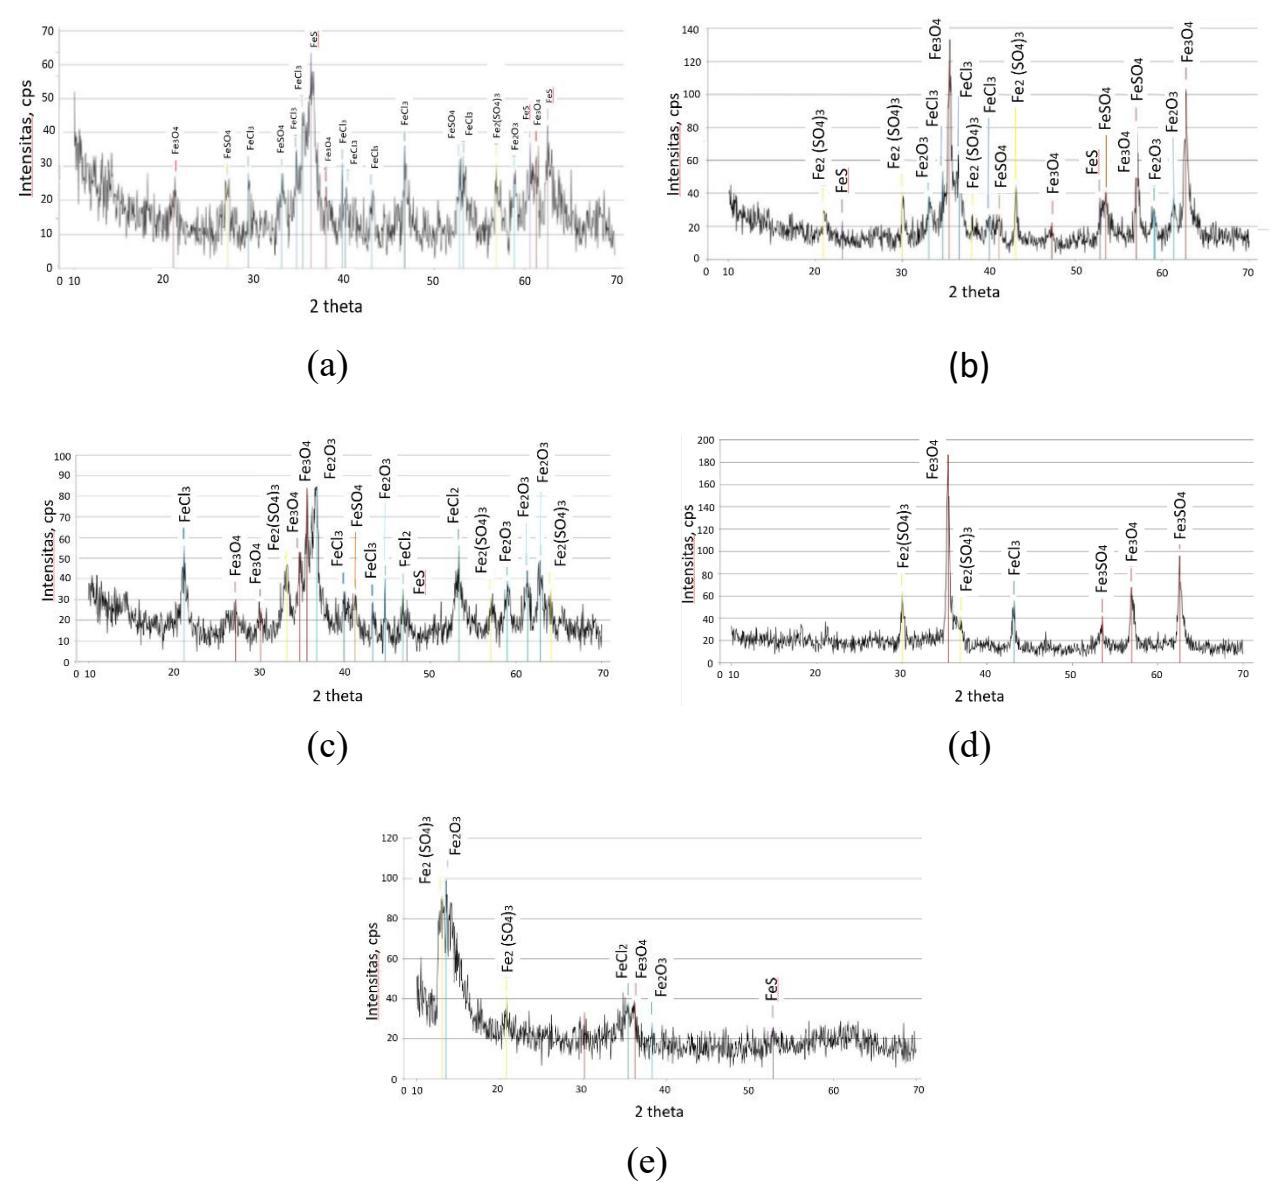
A comprehensive examination of the data presented in Figure 12 reveals the presence of various corrosion product compounds on five distinct surfaces: (a) metal CS uniform circuit, (b) under crevice circuit, (c) under galvanic circuit, (d) inner corrosion product, and (e) outer corrosion products. These compounds encompass FeCl<sub>3</sub>, Fe<sub>3</sub>O<sub>4</sub>, Fe<sub>2</sub>(SO<sub>4</sub>)<sub>3</sub>, Fe<sub>2</sub>O<sub>3</sub>, FeSO<sub>4</sub>, FeCl<sub>2</sub>, FeS, Fe(OH)<sub>3</sub>, and FeO.

This group of substances clearly shows how the metal element, iron (Fe), interacts with sulfate ions  $(SO_4^{2-})$ , chloride ions  $(Cl^{-})$ , and oxygen from the water. Among these ions, chloride ions, as shown in Table 1) are known to be highly corrosive and are found in high concentrations. The variations in the appearance of small peaks on the XRD curve indicate the presence of other substances in very small amounts, known as trace and noise phases.

**Figure 12.** XRD analysis of corrosion product layer on CS coupon after 4 years in PUSPIPTEK raw water pool. (a) Metal CS uniform circuit; (b) under crevice circuit; (c) under galvanic circuit; (d) inner corrosion product; (e) outer corrosion products.
