Formation mechanism of iron tubercles during corrosion of water supply pipes

Abstract

Keywords: pitting corrosion, corrosion tubercle formation, carbon steel, water supply systems.

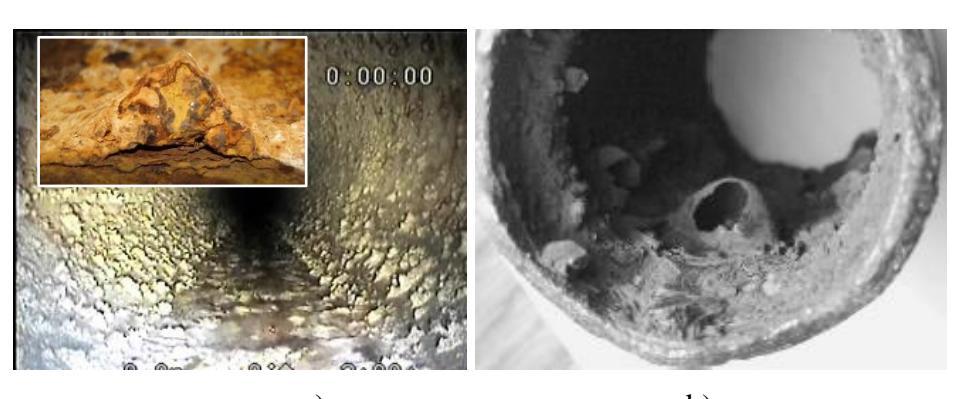
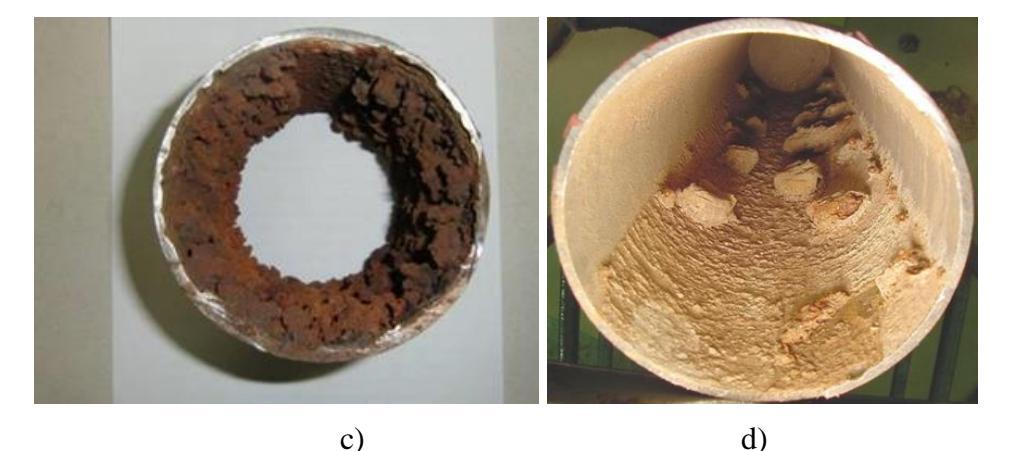
Figure 1. Examples of corrosion deposits formed on the inner surface of pipes: a - steel main water conduit DN900; b - fire sprinkler water supply [2]; c - galvanized pipe DN100, hot water supply system; d - galvanized steel pipe in a dry pipe system DN100 [3].

As the thickness of the scale increases, it becomes increasingly difficult for the oxidant to diffuse to the metal-water interface. At this stage, various structural features of corrosive deposits begin to form. The deposits formed on the surface are not homogeneous, and therefore oxidants penetrate into some areas at the metal-water interface. This causes the formation of concentration oxidation cells that contribute to a localized attack on bulk iron. Under these conditions, metallic iron is dissolved at the anode sites beneath the thicker deposits, while electrons are discharged at the adjacent oxidant-rich cathode sites. Localized corrosion results in larger deposits above the anode and the formation of tubercles. The thickness of the shell-like dense layer corresponds to the depth of oxidizer penetration into deposits. Within the sediment, a slower rate of Fe (II) oxidation is predicted, and the formation of goethite, magnetite and green-rust phases is possible. A shell-like dense layer, which is a mixture of goethite and magnetite, is expected to form under these conditions, thereby creating a complete tubercle structure. As the tubercles grow, they cover more and more surface areas and may eventually merge with other tubercles, covering the entire pipe surface (Figure 1).

As a possible variation of the described mechanism of tubercle formation, we can mention the growth of a single macrobubble covered with a film of iron (hydro)oxides. Such tubercles can be seen in Figure 1b and 1d, they look like frozen bubbles, with a thin shell and almost empty inside. It can be assumed that the released hydrogen accumulated in a macrobubble with a film of corrosion products gradually formed on its surface; and this film gradually hardened over time. Such a growth mechanism is favored by the absence of water flow (plus oxygen deficiency conditions as a consequence) typical for fire suppression systems. Also, the resulting gases can lift part of the upper layer of sediments without the breakthrough of gases to the outside – like a "bubble inflation". We sometimes found similar completely hollow tubercles in pipelines when examining hot water supply systems.

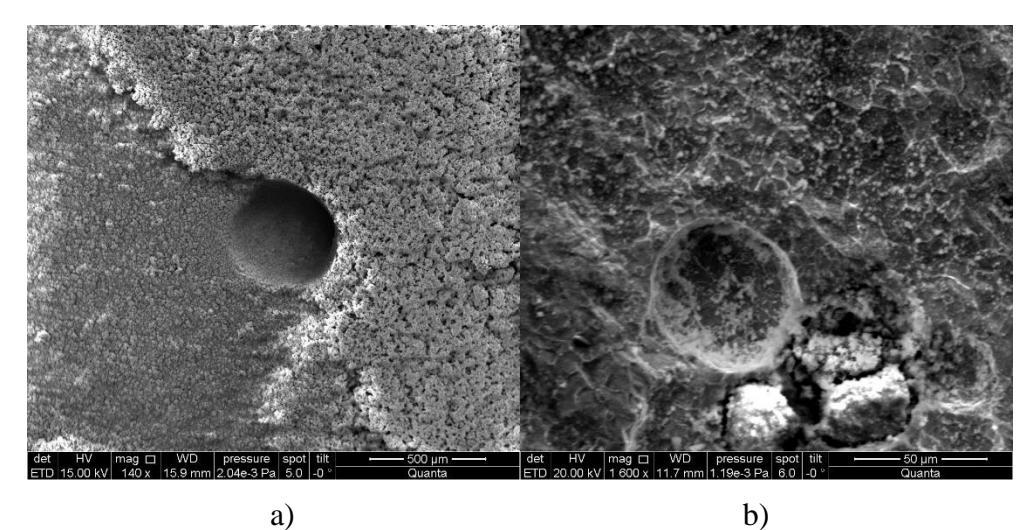
Figure 2. Examples of corrosion sludge layer formation during corrosion with predominantly oxygen depolarization: a - surface of corrosion sediment; b - metal surface after removal of loose sediment layer.

Conclusions, made in [11] about two different mechanisms of deposit formation and tubercles nucleation can be illustrated by photos of a fragment of carbon steel pipe made of St.3 (analogues – 1.0114, Fe37-xx, S235) (Figure 2). Microphotographs were obtained by the authors using SEM Quanta 250FEI in the course of corrosion research of steel water supply pipes in the laboratory of Water supply and wastewater disposal department. The pipe sample was kept in a tank with cold tap water for 90 days. The water in the tank was periodically refreshed. A solid layer of sediment was formed on the inner pipe surface as a result of corrosion. There were several round holes in the form of craters (Figure 2a), going deep under the layer of sediment. Figure 2b shows the surface of this sample after removal of the sludge.

The micrograph shows that there was uniform corrosion on most of the surface, and at one point there is a deepening in the form of pitting. The corrosion of the sample occurred with an increase in total weight, which is characteristic of experiments carried out under static conditions. The sediment on the sample surface is loose and permeable to oxygen, so under the layer of sediment the formation of tubercles is possible due to local oversaturation of corrosion products over the section of pipe surface. The average corrosion rate determined by metal loss was $0.118 \text{ g/m}^2 \cdot \text{h}$. However, the same fragment has deep surface damage, indicating that the corrosion process proceeded at a high rate in the pitting, which is more typical for corrosion with hydrogen depolarization. In [26], devoted to the study of pitting corrosion, it was shown that in cold water the formation of a dense layer starts above the anode with gradual overlapping of its entire surface. At the same time, the anode zone of metal destruction is constantly moving, as evidenced by the many overlapping hemispherical depressions on the steel surface. The displacement of anodic and cathodic areas, *i.e.* their repassivation, ends when the dense layer is finally fixed on the metal surface due to electrostatic forces. In the experiment conducted, the formation of tubercles began after 56 days.

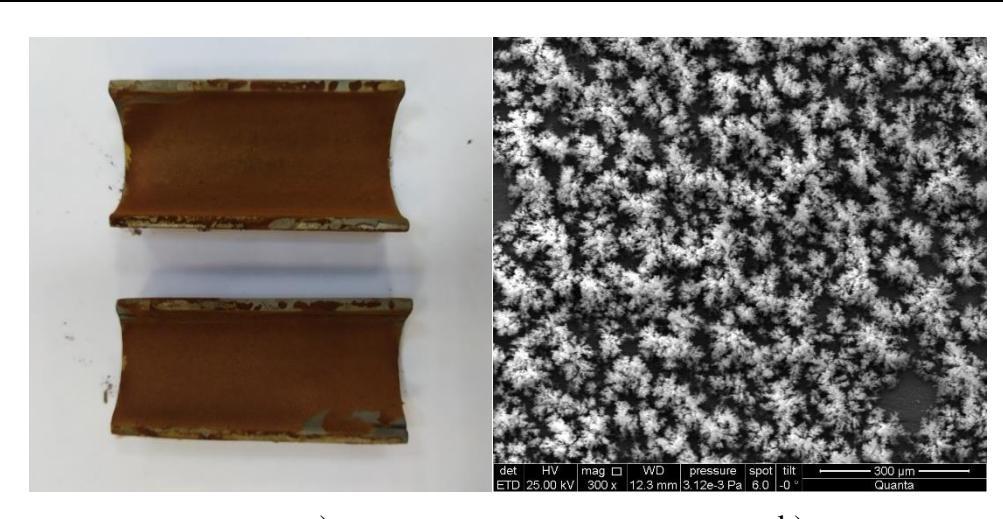
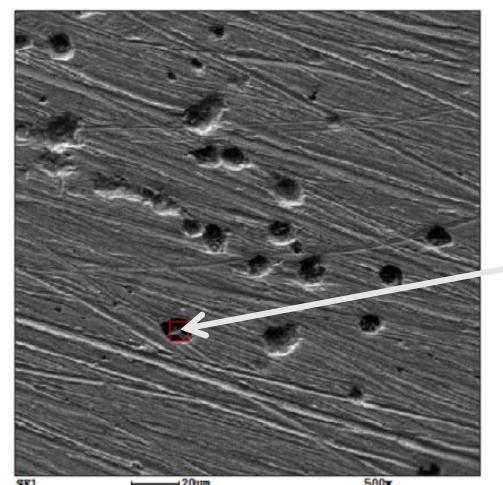
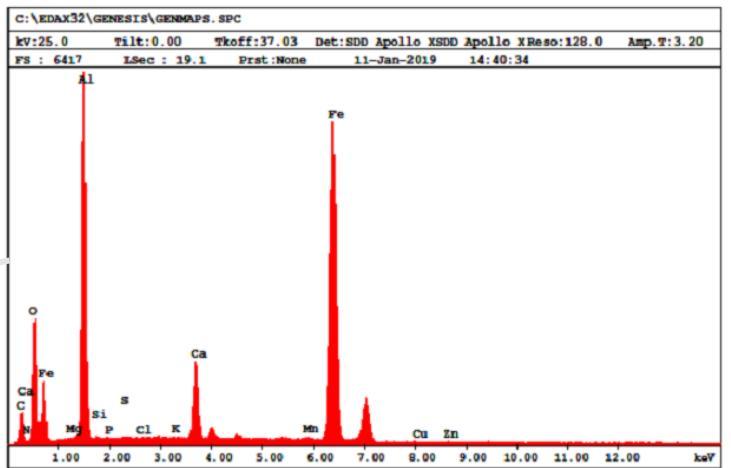
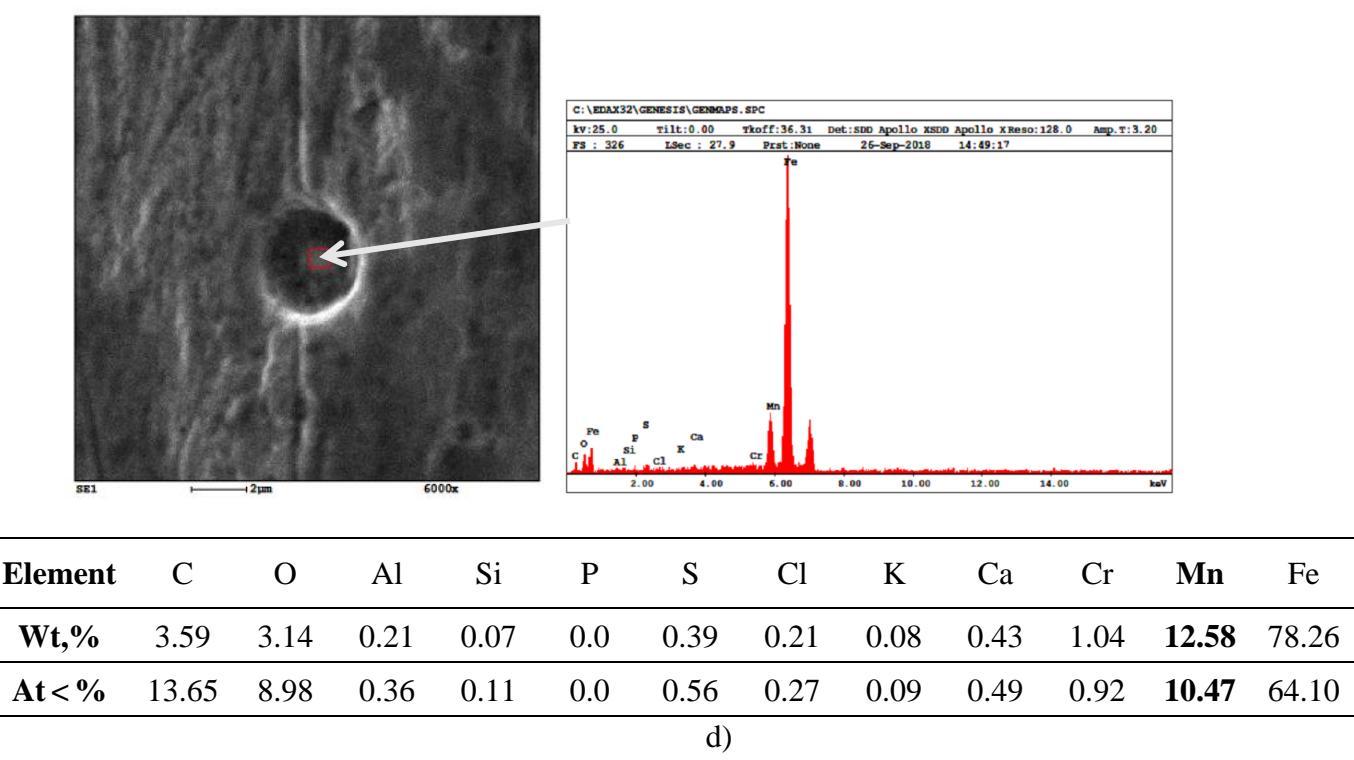
Figure 3. Microphotographs of corrosion indicators (a, b) with surface inclusions of aluminum (3c) in the experiment with hot water and manganese (3d) in the experiment with cold water.

At low water velocity, as well as in static conditions, corrosion appears to proceed uniformly on most of the sample surface (Figures 3a and 3b). However, after gentle removal of sediment it is possible to see a large number of depressions randomly scattered on the surface (Figure 3c); as a rule, there are round and having diameter up to 50 microns. In the depression center in some cases lighter spots are observed, which at the further study by means of SEM and energy dispersive spectroscopy, were identified as manganese or aluminum inclusions (Figure 3c and 3d). Thus, it can be assumed that the depressions on the metal surface shown in Figure 2 were also formed as a result of local corrosion in the presence of metal inclusions more negative than iron. In this case, the high corrosion rate leads to rapid formation of tubercles, as shown in Figure 1b and 1d.

Element	С	Ν	Ο	Mg	Al	Si	Р	S
Wt,%	12.13	0.8	15.42	0.1	23.97	0.14	0.05	0.06
At < %	26.49	1.49	25.28	0.11	23.30	0.13	0.04	0.05
Element	Cl	К	Ca	Mn	Fe	Cu	Zn	
Wt,%	0.07	0.08	4.62	0.48	41.75	0.19	0.16	
At < %	0.05	0.05	3.02	0.23	19.61	0.08	0.07

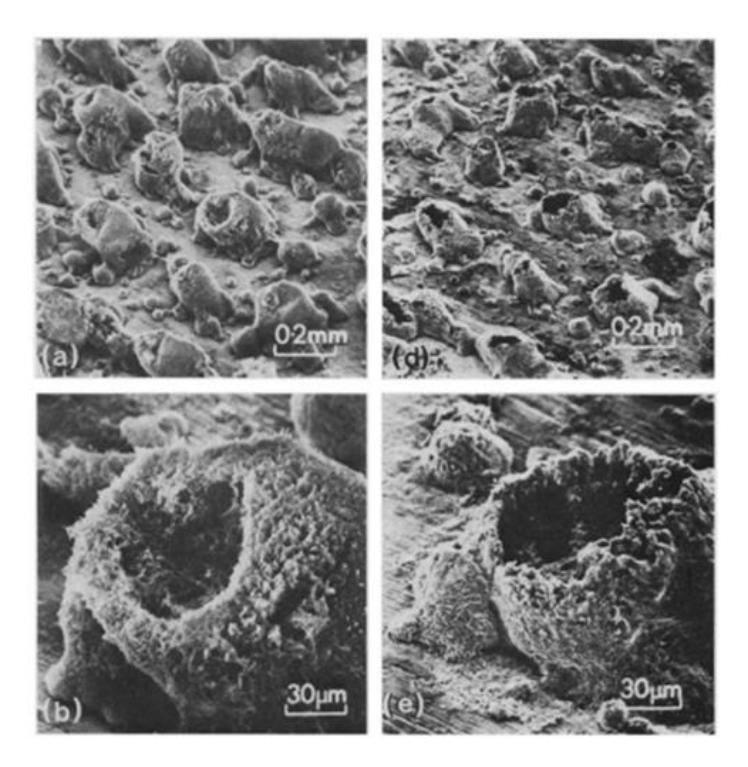
Figure 4. Sequence of scanning electron micrographs showing the effects of deoxygenation upon the structure of scale formed on cast iron at 50°C and pH = 6. a, b – after oxygenation at 18.00 ppm O₂ showing γ -FeOOH overlying Fe₃O₄; d, e – after deoxygenation to <0.03 ppm O₂ showing substantial removal of γ -FeOOH [25].

Figure 4 shows microphotographs that demonstrate the nucleation of tubercles on a polished cast iron surface [25]. At pH = 5.9, the deposits initially consisted of a set of nodules oriented in the direction of water flow (Figure 4a). The shape of the tubercle in the form of a crater may indicate that corrosion proceeds with hydrogen depolarization and with the formation of hydrogen bubbles forming their structure.

The experiments described in [25] demonstrated that the cathodic reduction of γ -FeOOH to Fe₃O₄ takes place when the corrosive deposits are in contact with deoxygenated water. The reaction can occur: (1) when the O₂ concentration is reduced to <~1.0 ppm and γ -FeOOH is significantly removed from the sediment and (2) in oxygenated water, when γ -FeOOH continuously forms on the outer surface of the sediment and is then cathodically reduced to Fe₃O₄ which eventually becomes the predominant phase of the precipitate.

The authors compare the obtained ferrotubes with the corrosion tubercles described by McEnaney and Smith [25]. The hollow corrosion tubercles shown in Figure 4 formed on ferrous metals show a three-layer structure: oxidized iron in form of lepidocrocite on the outside, reduced iron such as green rust inside and magnetite sandwiched between them [25].

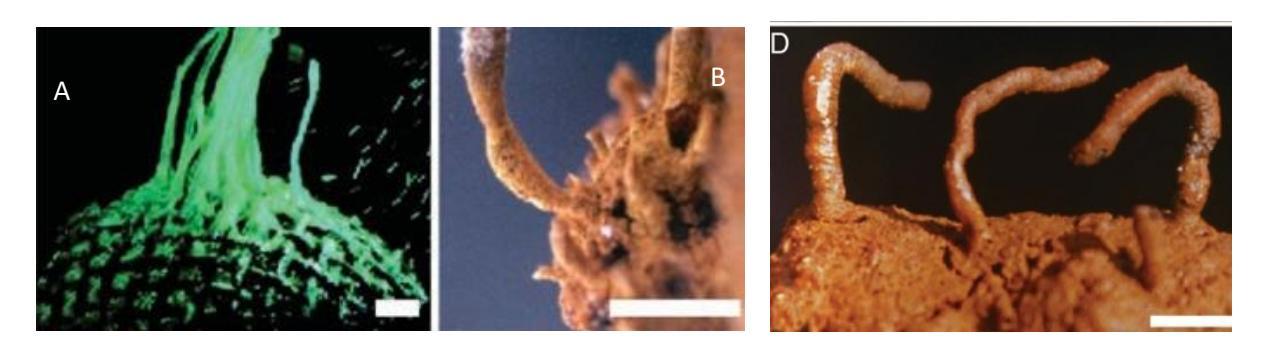
Figure 5. Tube morphologies. A – columnar precipitation around injected jets of aqua ammonia; B – tube diameter varying as current is transiently decreased (narrow region) then increased and held at a higher level (wider upper half of tube); D – bent tubes grown over small magnets. (Scale bars, 5 mm.) [31].

Another approach to describing the mechanism of tubercle formation and growth is given in [6]. Gerke et al. [6], based on the analysis of Stone's and Goldstein's research results [31], made the assumption that tubercles grow on the cathode of the electrochemical cell. The authors suggested that "if, with further investigations, it can be proven that tubercle formation does occur at the cathodic site of the electrochemical cell, it will significantly add to our understanding of tubercle formation and growth". In their work, Stone and Goldstein [31] studied the effect of patterns on the formation of tubular structures formed electrochemically in iron sulfate and ammonium sulfate solutions. The authors describe the self-organized process of tubular structures growth as a result of the template action of gas bubbles (Figure 5). Bubbles formed at the cathode of the electrochemical cell move the film formed at the gas-solution interface; bubble detachment leaves a ring of material that elongates the tube, and the process continues. The bubbles form and collapse at intervals of one to several seconds and the "ferrotubes" grow to millimeters in tens or hundreds of minutes. The patterning of the bubbles and the redox gradient results in a regular tubular shape. In addition, it was found that the iron oxides/hydroxides in the tube wall are arranged in an oxidation sequence (Figure 6).

The tube radius decreases with decreasing current (Figure 5b), so at very low currents, when the gas bubble hang time increases to hundreds of seconds, the tubes are closed because the sediment film is so dense and thick that it can withstand the bubble pressure.

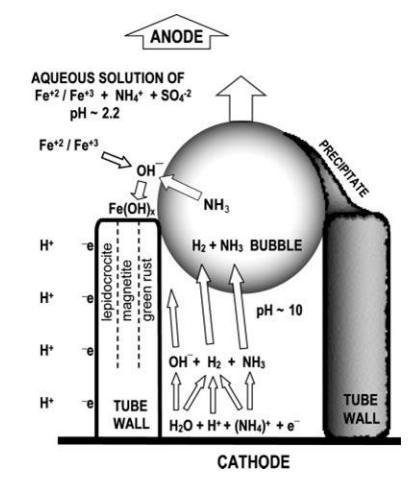
Figure 6. Mechanisms involved in tubular precipitation templated by bubbles [31].

The model of ferrotube growth shown in Figure 6 assumes five main sequential stages, starting at the base of the tube and moving up [31].

- 1. Water and H⁺ ions are reduced at the cathode surface, producing hydroxide ions and hydrogen gas, and ammonium ions are deprotonated to produce ammonia gas.
- 2. The mixed gases move up through the tube as individual bubbles and acts as a pump, pushing the alkaline solution out of the open top.
- 3. When the bubbles remain at the tube opening, the alkaline solution and ammonia react with the bulk, acidic, ferrous solution. The green rust precipitates around the rim and over the surface of the bubble as a thin film.
- 4. The bubble detaches, leaving a ring of deposited material around the rim.
- 5. The green rust quickly turns into magnetite inside the tube and oxidizes to lepidocrocite on the outside.

The tubercle shown in Figure 7a has a diameter of 1.5 to 2.0 mm and a height of 4 mm. The growth rate of the tubercle is 5.3 mm/year. However, in contrast to the ferrotube schematically shown in Figure 6, the core of the tubercle consists of loose amorphous sediment.

The presence of a loose core in the tubercles (Figure 7d) indicates that the formation of the tubercles differs from the pattern shown in Figure 6. Apparently, there are many microgalvanic cells on the metal surface (Figure 7e), including all four components. Microgalvanic cells generate microbubbles of hydrogen, which unite in the upper part and in the boundaries of the dense layer form a tubercle as shown in Figure 7a, 7c and 7f. The decrease in diameter of the tubercles in the upper part is associated, in our opinion, with difficulties in the inflow of external solution to the corrosion site and, consequently, an increase in electrical resistance. Thus, the limiting stage of the corrosion process is the inflow of the solution to the metal surface. In this case, if there is a lot of electrolyte inside the tubercle, the process ends with the appearance of through pitting. Otherwise, the corrosion process slows down or stops completely.

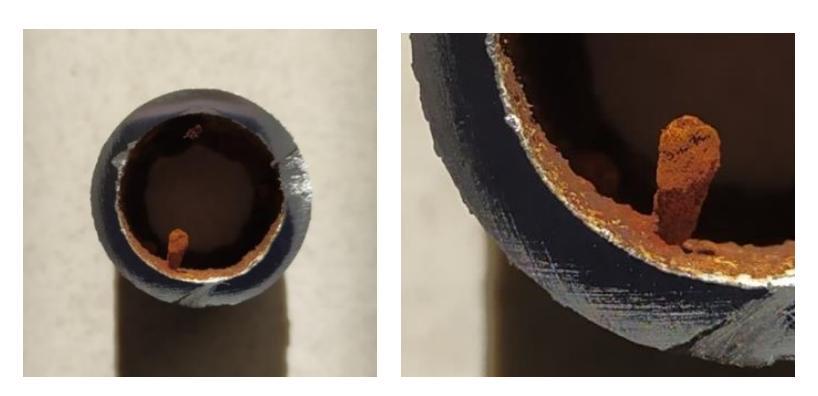
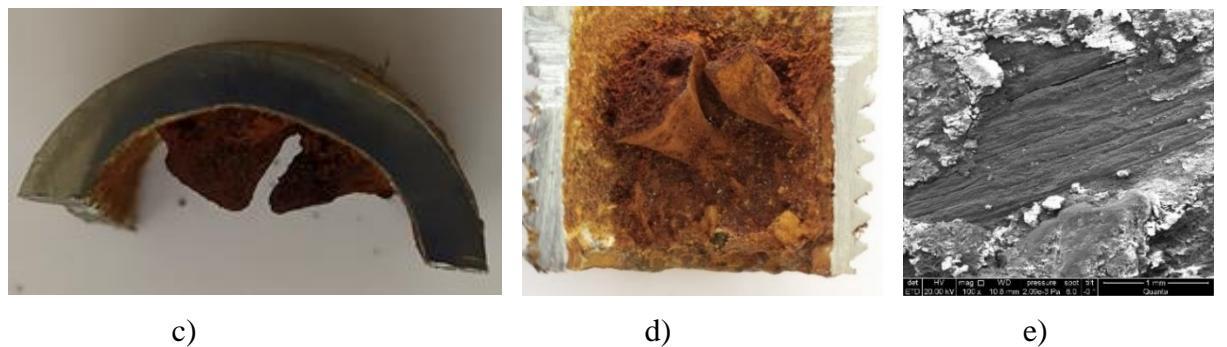
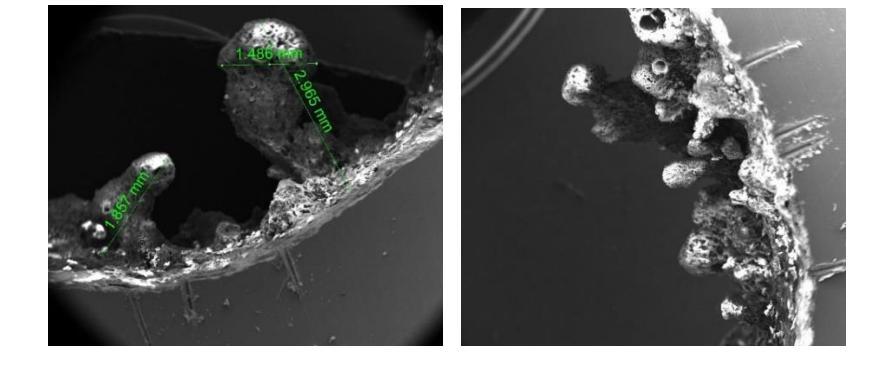
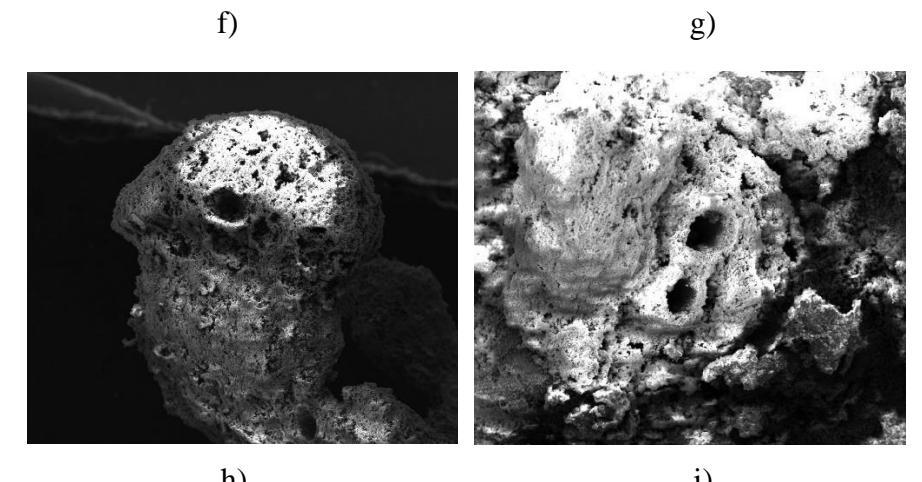
h) i) Figure 7. The formation of ferrotube-like tubercle during corrosion of a galvanized pipe in a hot water supply system (a-c, f, g); structural elements of tubercles (d, e, h, i).

The tubercles shown in Figure 7 can serve as an illustration of possible occurrence of ferrotube-like structures in steel pipes. The tubercles shown in Figure 7, were found by the authors of this article when studying the corrosion of steel galvanized pipes in a hot water supply system. The diameter of the pipe was 15 mm, and the time spent in the HWS system was 224 days. The water temperature was 50°C, flow velocity was 6 cm/s. In the course of the experiment, the composition of sediment formed on the pipe walls during operation was studied and the degree of zinc coating damage was determined.

Figure 7c and 7d show two tubercles formed under similar conditions in the experiment described above. In Figure 7d after removing the top of the tubercle, one can see a thin dense layer and a loose core. For the tube samples shown in Figure 7, the structure and composition of the sediment was analyzed on a Quanta 250 FEI electron microscope. Lepidocrocite predominates in the upper part of the tubercle and Fe₃O₄ – in the bottom. A microphotograph of a depression on the metal surface under a large tubercle is shown in Figure 7e. Micrographs of a number of similar tubercles from the same experiment are shown in Figure 7f, g – in their shape they are most similar to the ferrotubes shown in Figure 5.

Understanding how tubercles form and grow makes it possible to identify any ways to influence their growth and prevent the negative effects associated with pipeline failure and water quality degradation. The tubercles shown in Figure 7 were formed under conditions of maintaining a constant flow rate and temperature of hot water for a long time, so the growth of tubercles proceeded uniformly, and if the experiment was continued, it would lead to the appearance of through pitting. Our accumulated experience of examination of various pipelines shows that prolonged operation with constant parameters to a greater extent contributes to accelerated corrosion. Figure 1a shows a steel main water pipeline with uniformly distributed tubercles around the perimeter, which has been in operation for 43 years. The most suitable explanations for prolonged operation could be seasonal variations in water quality, fluctuations in daily water consumption, and, most likely, changes in temperature during the summer and winter months.
